"While you're doing the motor, could you have a look at the steering for me, only the handling doesn't seem too good!" These were the instructions given when the Ajay 250 was handed into Deeprose Bros. for a hottom end overhaul.

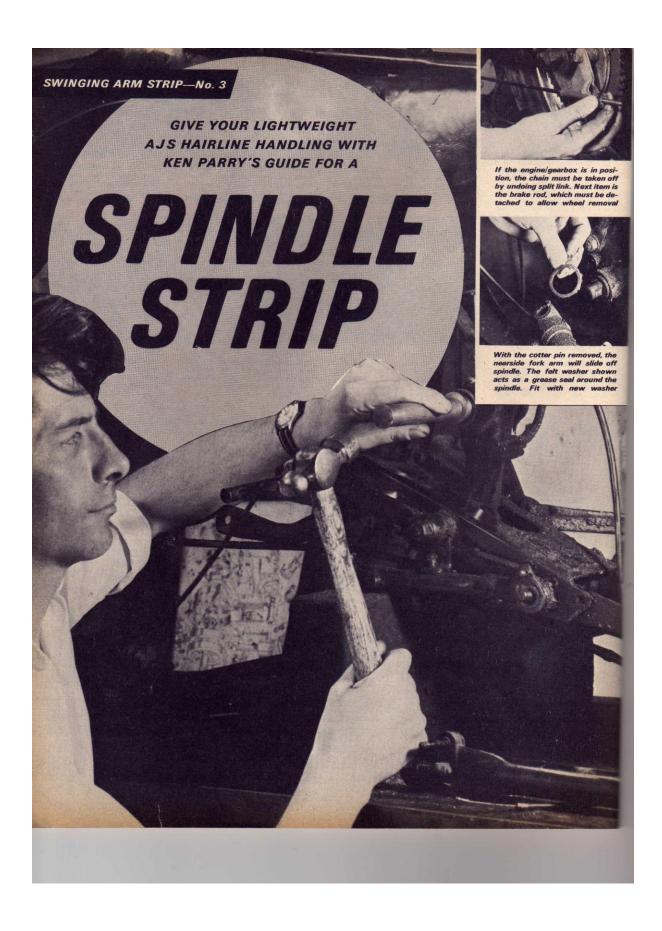
The speedometer drive is taken from the rear wheel and the cable has to be undone as shown. Note position of drive-box so that it is replaced the same on reassembly

With all auxiliaries detached, all that remains is to loosen the wheel spindle nuts and slide the rear wheel from forks. Top chainquard will now also lift away

By disconnecting both suspension legs on the forks, it is simply a matter of pivoting the forks downwards to expose cotter pin, which holds the two arms together

With the bike frame turned on its side to expose the cotter pin, the locknut is removed and then a hammer and drift employed to knock out the pin

The other half of fork slides out of bushes complete with spindle. If spindle is worn, complete fork unit is required. See that washer is set as seal on bush this side

The bronze swinging arm bushes are easily drifted from the frame from inside of the housing. Note grease nipple. If lubricated regularly, very little wear takes place

A new bush is gently drifted into frame. It should not need reaming. Reassemble the forks in reverse order. Shims are available to take up any sideways fork movement

If the engine is in the frame, a hole can be drilled through sprocket guard plate to allow drift through to knock out bush. The rear wheel must be removed
